**Flood Control Project Maintenance
Levee Inspections**

Fall 2011 Levee Maintenance Deficiency Summary Report

San Joaquin River Basin

Reclamation District No. 2085 Kasson

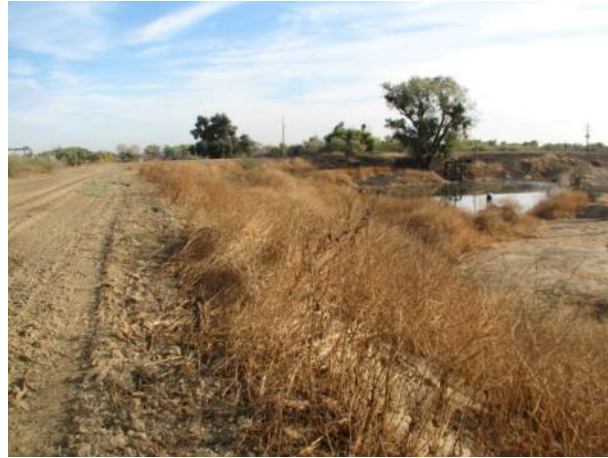
jeto_f_20110923_208.jpg

Levee Mile Report Line	1
Start Levee Mile	0.41
End Levee Mile	0.64
Location	Land Side
Category	Earthen Levee
Item	Vegetation

Tall weeds remain on the landside levee slope.

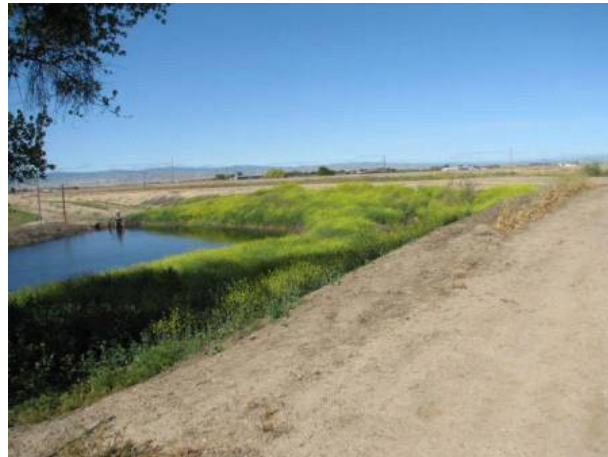
jeto_f_20110923_209.jpg

Levee Mile Report Line	1
Start Levee Mile	0.41
End Levee Mile	0.64
Location	Land Side
Category	Earthen Levee
Item	Vegetation

04/28/2011 Weeds taller than 12" inhibit visibility of landside slope and tow.

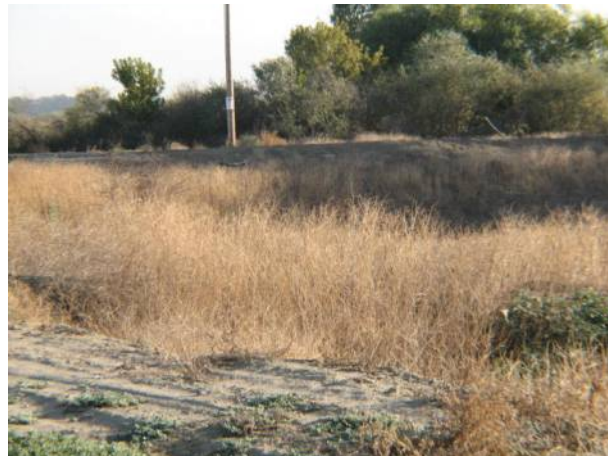
jeto_f_20111110_548.jpg

Levee Mile Report Line	1
Start Levee Mile	0.41
End Levee Mile	0.64
Location	Land Side
Category	Earthen Levee
Item	Vegetation

11/03/2011 Updated photo vegetation issue still remains on landside.

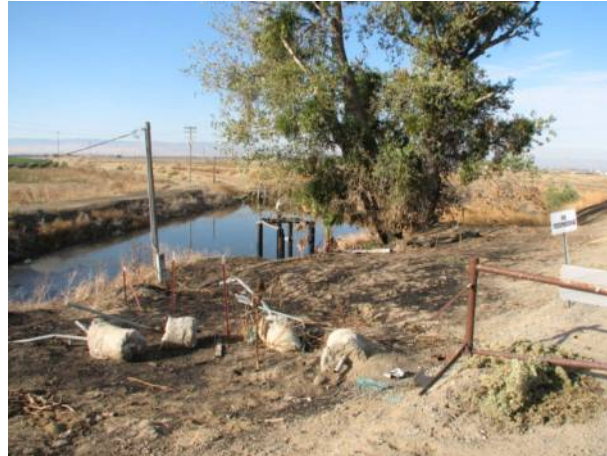
Levee Mile Report Line	2
Start Levee Mile	0.47
End Levee Mile	0.47
Location	Water Side
Category	Earthen Levee
Item	Encroachments
Drainage discharge pipe penetrates levee with no closure device.	
jeto_f_20110923_210.jpg

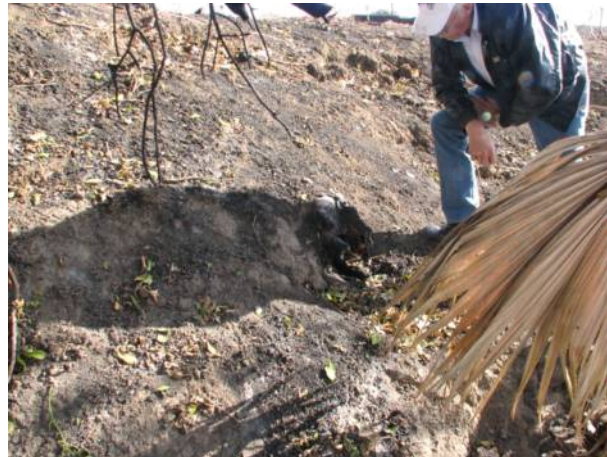
Levee Mile Report Line	2
Start Levee Mile	0.47
End Levee Mile	0.47
Location	Water Side
Category	Earthen Levee
Item	Encroachments
Opening on landside appears to consist of melted poly pipe halfway up levee slope. Opening on waterside is heavily corroded steel pipe.	
jeto_f_20110923_211.jpg

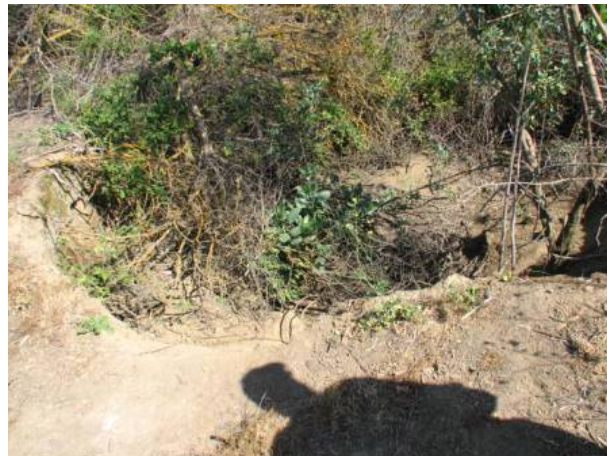
Levee Mile Report Line	2
Start Levee Mile	0.47
End Levee Mile	0.47
Location	Water Side
Category	Earthen Levee
Item	Encroachments
04/28/2011 Area around discharge pipe appears to be in an area of erosion. Area was found after weeds were cleared.	
jeto_f_20110923_212.jpg

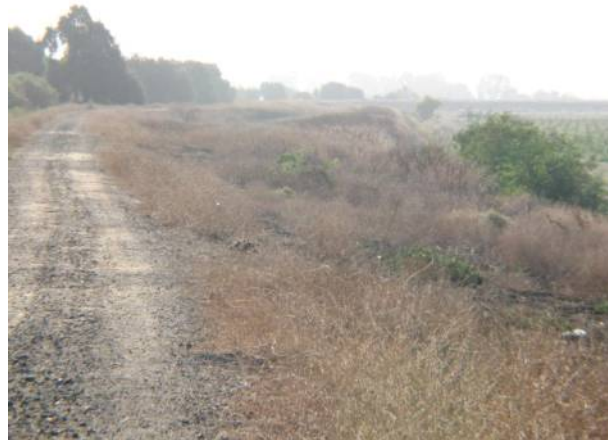
jeto_f_20111110_549.jpg

Levee Mile Report Line	3
Start Levee Mile	0.51
End Levee Mile	0.87
Location	Land Side
Category	Earthen Levee
Item	Vegetation

11/03/2011 Vegetation control measures have not been started yet.

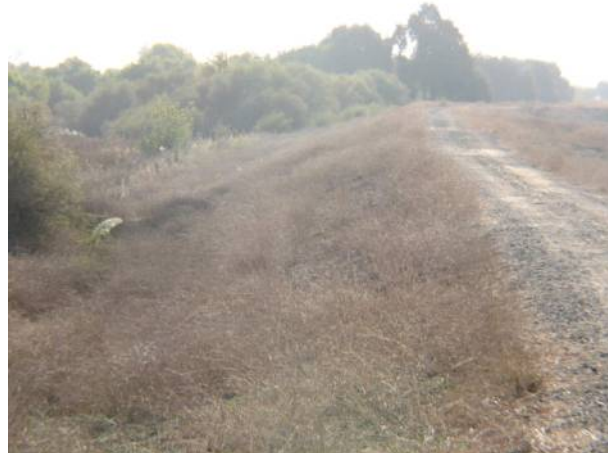
jeto_f_20111110_550.jpg

Levee Mile Report Line	4
Start Levee Mile	0.51
End Levee Mile	2.08
Location	Water Side
Category	Earthen Levee
Item	Vegetation

11/03/2011 Waterside vegetation management has not started yet.

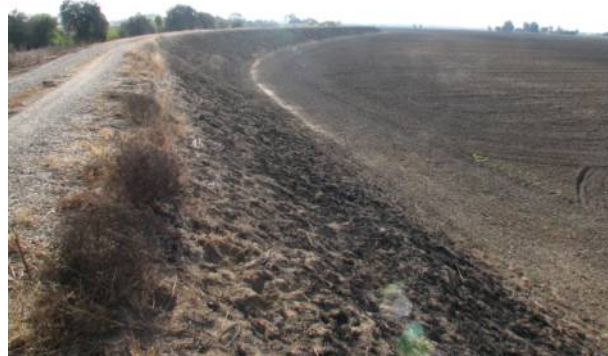
jeto_f_20110923_213.jpg

Levee Mile Report Line	7
Start Levee Mile	0.89
End Levee Mile	1.18
Location	Land Side
Category	Earthen Levee
Item	Encroachments

Tilling of soil on the levee toe will destabilize the slope over time.

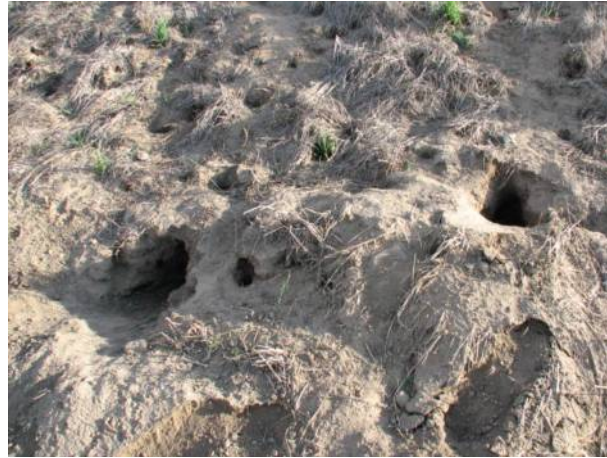
Levee Mile Report Line	9
Start Levee Mile	1.18
End Levee Mile	1.18
Location	Land Side
Category	Earthen Levee
Item	Animal Control
11/03/2011 Several burrows present.	
jeto_f_20111110_551.jpg

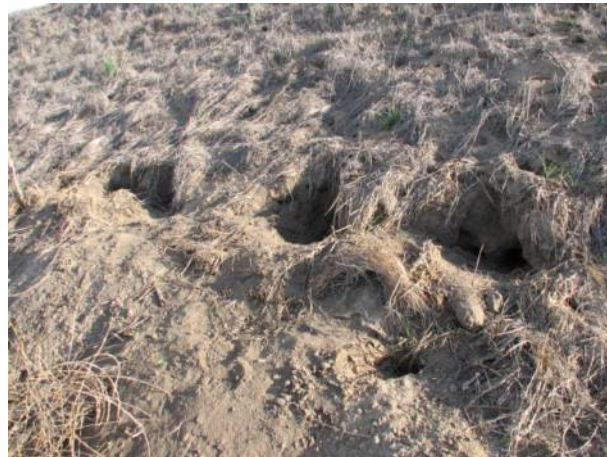
Levee Mile Report Line	9
Start Levee Mile	1.18
End Levee Mile	1.18
Location	Land Side
Category	Earthen Levee
Item	Animal Control
11/03/2011 Second photo more burrows in the same location.	
jeto_f_20111110_552.jpg

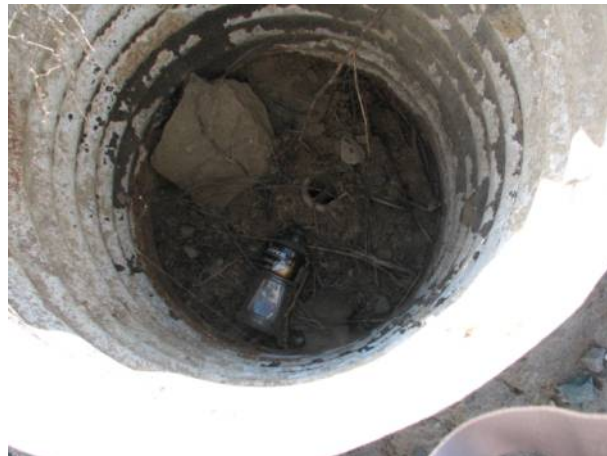
Levee Mile Report Line	11
Start Levee Mile	1.35
End Levee Mile	1.35
Location	Crown
Category	Earthen Levee
Item	Encroachments
Photo of anti siphon at waterside shoulder.	
jeto_f_20110923_214.jpg

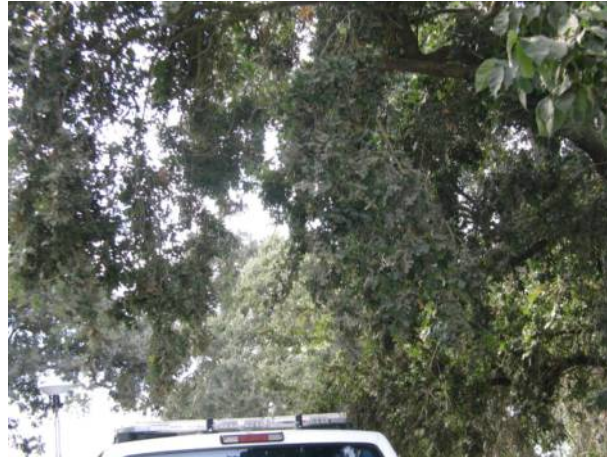
jeto_f_20111110_554.jpg

Levee Mile Report Line	14
Start Levee Mile	2.45
End Levee Mile	2.45
Location	Crown
Category	Earthen Levee
Item	Trim / Thin Trees

11/03/2011 Tree needs to be trimmed up to a minimum of 12' over the roadway.

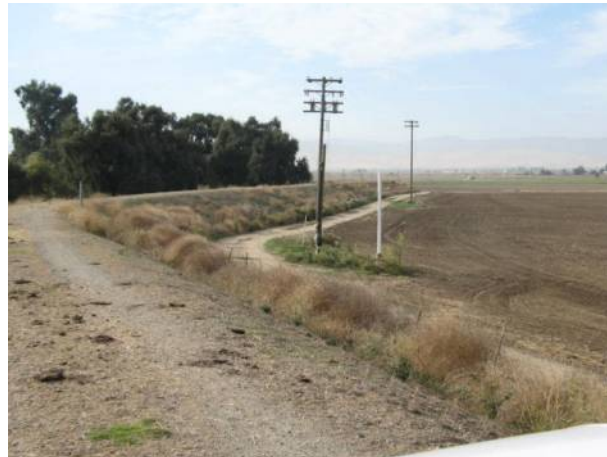
jeto_f_20111110_555.jpg

Levee Mile Report Line	17
Start Levee Mile	2.71
End Levee Mile	2.91
Location	Land Side
Category	Earthen Levee
Item	Vegetation

11/03/2011 Tumbleweed on landside slope and toe obscure visibility.

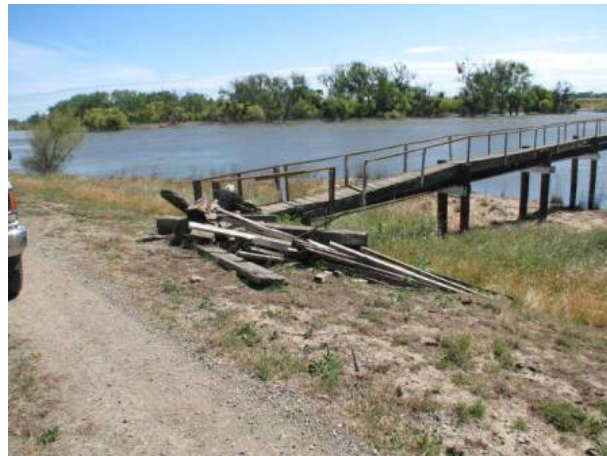
jeto_f_20110923_216.jpg

Levee Mile Report Line	18
Start Levee Mile	2.75
End Levee Mile	2.75
Location	Water Side
Category	Earthen Levee
Item	Encroachments

04/28/2011 Trash still present, item was noted in Fall 2010 inspection.

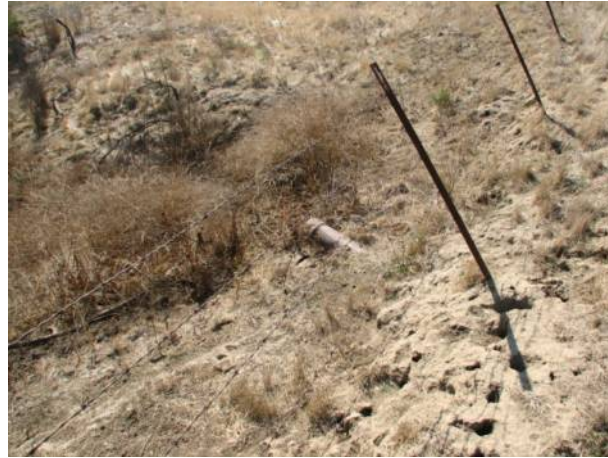
jeto_f_20110923_221.jpg

Photo of pipe penetration discharge off landside slope.

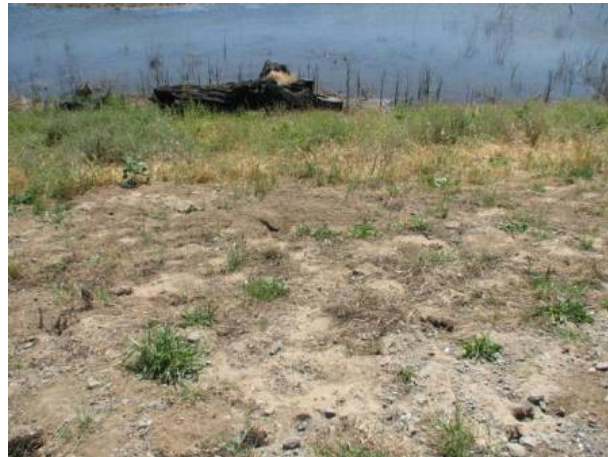
jeto_f_20110923_215.jpg

Levee Mile Report Line	23
Start Levee Mile	3.28
End Levee Mile	3.28
Location	Water Side
Category	Earthen Levee
Item	Animal Control

04/28/2011 Fresh burrow in center of picture, "porch" extends to the grass line.

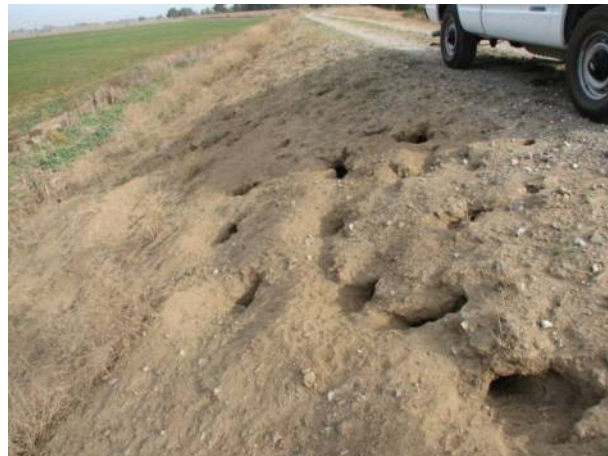
jeto_f_20111110_556.jpg

Levee Mile Report Line	24
Start Levee Mile	3.31
End Levee Mile	3.31
Location	Land Side
Category	Earthen Levee
Item	Animal Control

11/03/2011 Landside burrows.

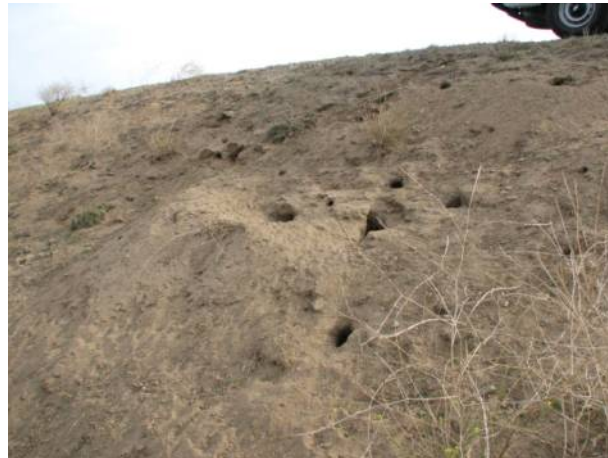
Levee Mile Report Line	24
Start Levee Mile	3.31
End Levee Mile	3.31
Location	Land Side
Category	Earthen Levee
Item	Animal Control
11/03/2011 More landside burrows at same location.	
jeto_f_20111110_557.jpg

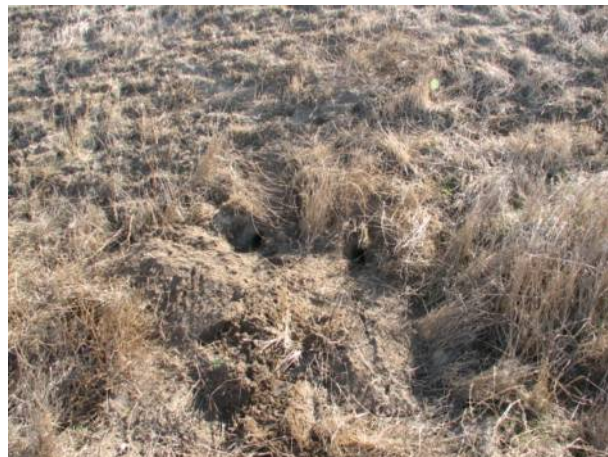
Levee Mile Report Line	27
Start Levee Mile	3.37
End Levee Mile	3.37
Location	Land Side
Category	Earthen Levee
Item	Animal Control
Rodent holes have been flagged for repair.	
jeto_f_20110923_222.jpg

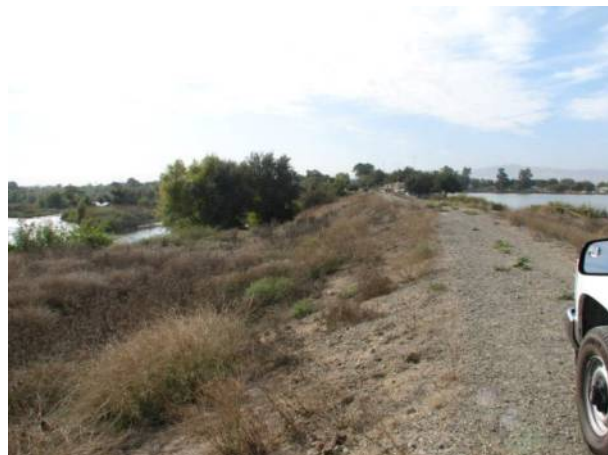
Levee Mile Report Line	31
Start Levee Mile	3.63
End Levee Mile	4.01
Location	Water Side
Category	Earthen Levee
Item	Vegetation
11/03/2011 Vegetation on water side is not being properly maintained. Top 20' from the hinge must be cleared.	
jeto_f_20111110_558.jpg

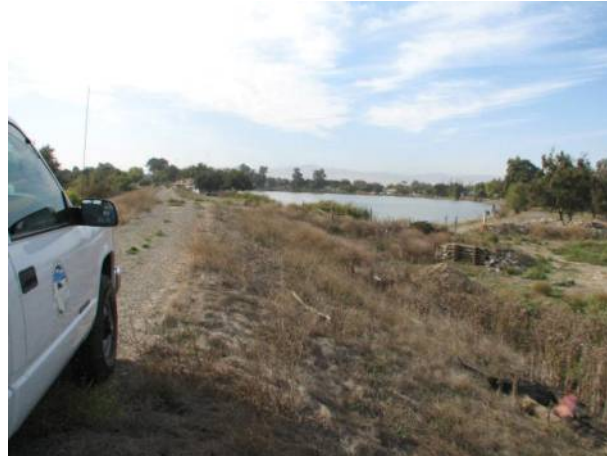
Levee Mile Report Line	33
Start Levee Mile	3.63
End Levee Mile	3.84
Location	Land Side
Category	Earthen Levee
Item	Vegetation
11/03/2011 Vegetation on landside must be controlled on the entire slope and 15' beyond the toe.	
jeto_f_20111110_559.jpg

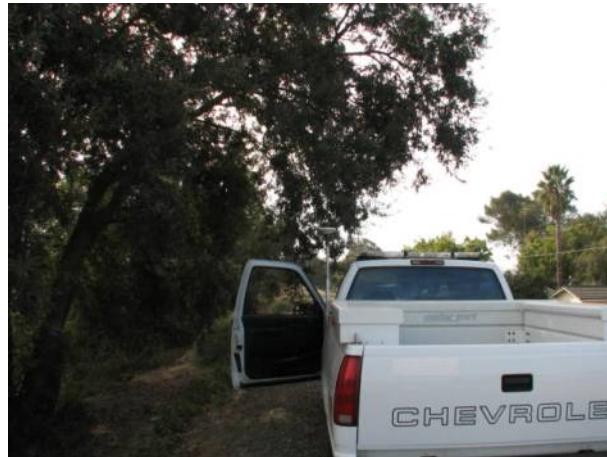
Levee Mile Report Line	35
Start Levee Mile	3.78
End Levee Mile	3.78
Location	Crown
Category	Earthen Levee
Item	Trim / Thin Trees
11/03/2011 Tree needs to be trimmed up to a minimum of 12' over the roadway.	
jeto_f_20111110_560.jpg

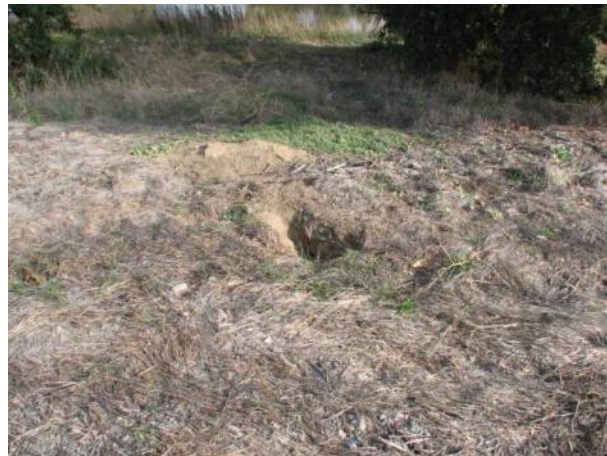
Levee Mile Report Line	37
Start Levee Mile	3.98
End Levee Mile	3.98
Location	Water Side
Category	Earthen Levee
Item	Animal Control
11/03/2011 Burrow on waterside.	
jeto_f_20111110_561.jpg

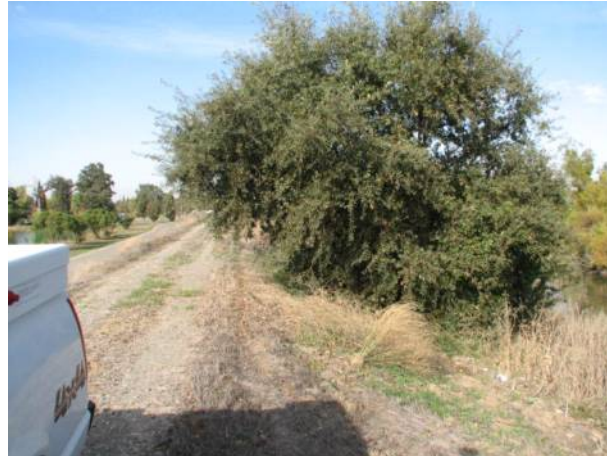
Levee Mile Report Line	38
Start Levee Mile	4.14
End Levee Mile	4.14
Location	Water Side
Category	Earthen Levee
Item	Trim / Thin Trees
11/03/2011 Tree on waterside needs to be trimmed up 5' over slope and up to a minimum of 12' over the roadway.	
jeto_f_20111110_562.jpg

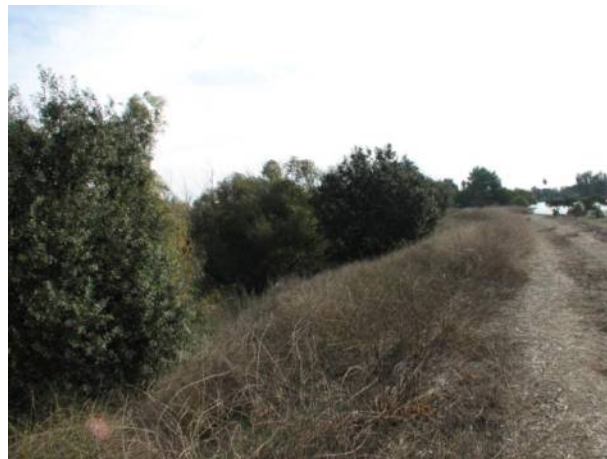
Levee Mile Report Line	39
Start Levee Mile	4.18
End Levee Mile	4.45
Location	Water Side
Category	Earthen Levee
Item	Vegetation
11/03/2011 Waterside vegetation needs to be maintained on the top 20' of the waterside slope.	
jeto_f_20111110_563.jpg

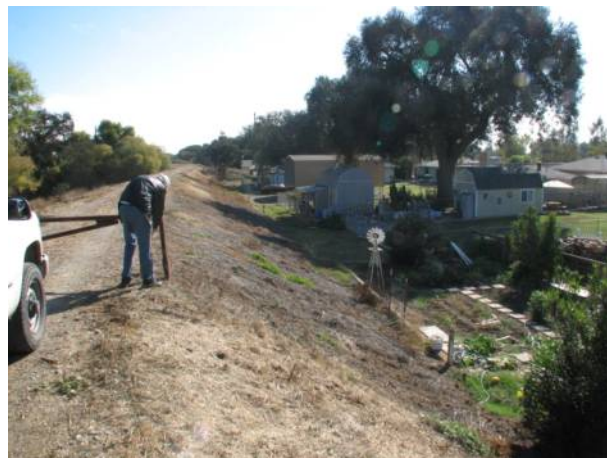
Levee Mile Report Line	42
Start Levee Mile	4.32
End Levee Mile	4.37
Location	Land Side
Category	Earthen Levee
Item	Encroachments
Updated photo of encroachments on landside toe.	
jeto_f_20110923_218.jpg

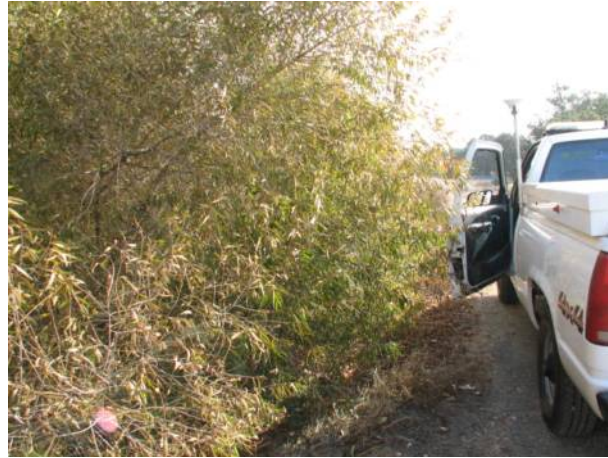
Levee Mile Report Line	43
Start Levee Mile	4.37
End Levee Mile	4.37
Location	Water Side
Category	Earthen Levee
Item	Trim / Thin Trees
11/03/2011 Tree needs to be limbed up to 5' above the ground on the waterside for visibility.	
jeto_f_20111110_565.jpg

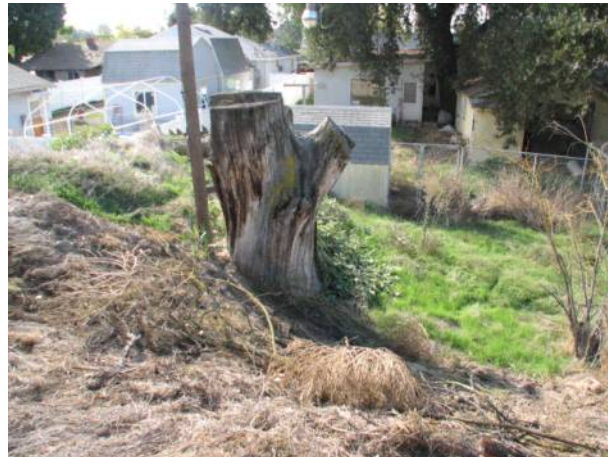
Levee Mile Report Line	44
Start Levee Mile	4.38
End Levee Mile	4.38
Location	Land Side
Category	Earthen Levee
Item	Trim / Thin Trees
11/03/2011 Large stump on landside slope.	
jeto_f_20111110_564.jpg

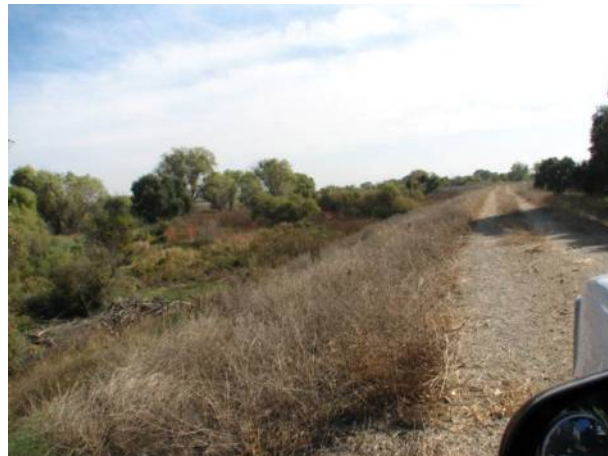
Levee Mile Report Line	46
Start Levee Mile	4.49
End Levee Mile	5.16
Location	Water Side
Category	Earthen Levee
Item	Vegetation
11/03/2011 Waterside vegetation needs to be managed on the top 20' of the slope.	
jeto_f_20111110_566.jpg

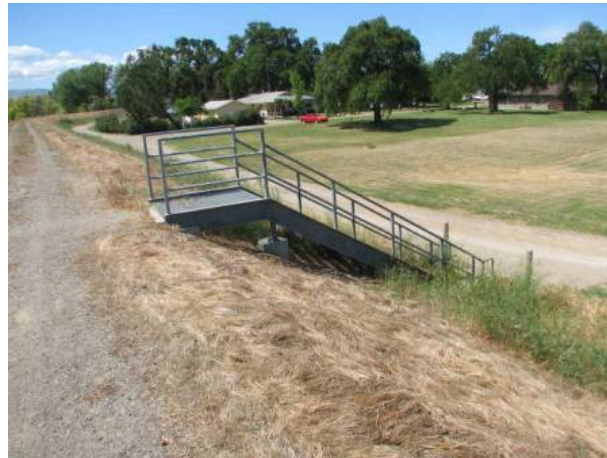
jeto_f_20110923_219.jpg

04/28/2011 Stairs on landside slope for monitoring station.

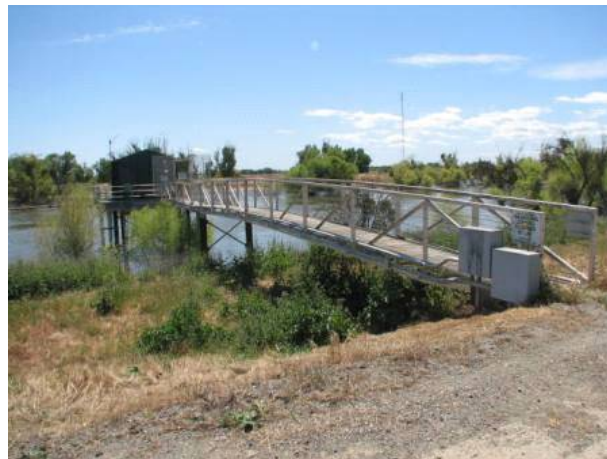
jeto_f_20110923_220.jpg

Levee Mile Report Line	49
Start Levee Mile	4.71
End Levee Mile	4.71
Location	Water Side
Category	Earthen Levee
Item	Encroachments

04/28/2011 Monitoring station.

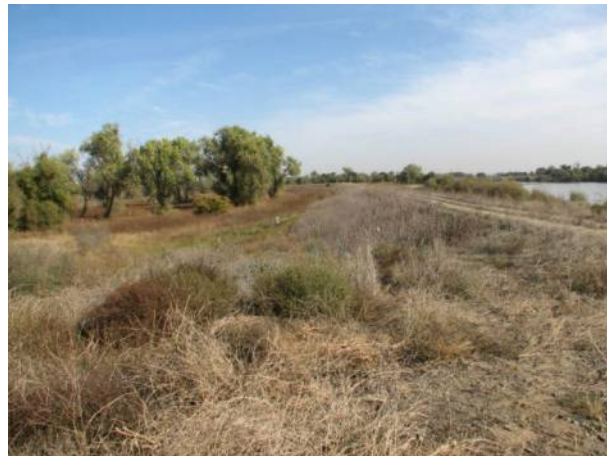
jeto_f_20111110_567.jpg

Levee Mile Report Line	50
Start Levee Mile	4.81
End Levee Mile	4.87
Location	Land Side
Category	Earthen Levee
Item	Vegetation

11/03/2011 Landside vegetation needs to be maintained for the full landside slope and 15' beyond the toe.

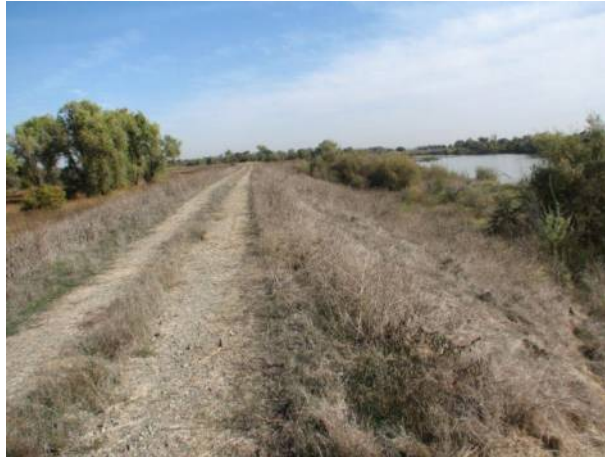
jeto_f_20111110_568.jpg

11/03/2011 Waterside vegetation has been sprayed, but needs to be removed so the top 20' of the slope is visible.

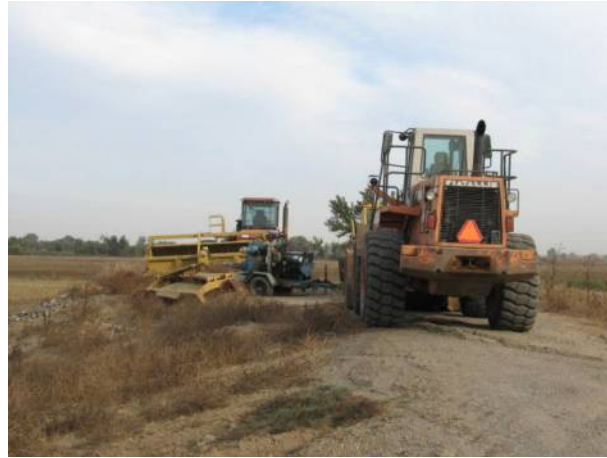
jeto_f_20111110_553.jpg

11/03/2011 Heavy equipment being stored on the levee crown at the end of the spur levee.

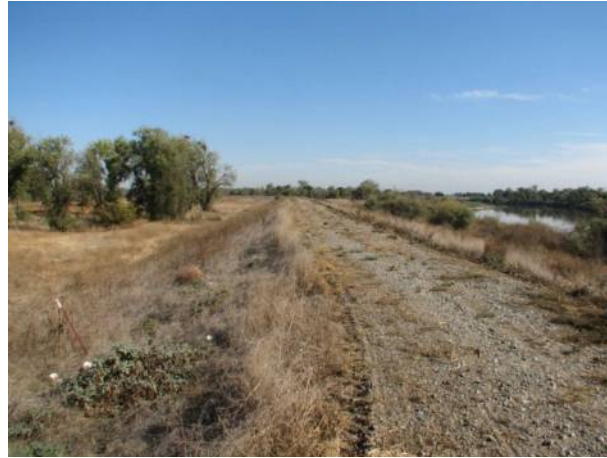
jeto_f_20110923_224.jpg

Unwanted weed growth on levee slopes.

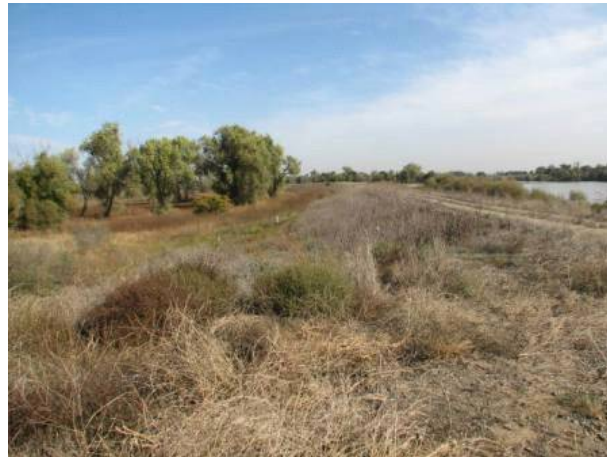
jeto_f_20111114_570.jpg

Levee Mile Report Line	1
Start Levee Mile	0.01
End Levee Mile	0.29
Location	Land Side
Category	Earthen Levee
Item	Vegetation

11/03/2011 Vegetation has been sprayed, but needs to be removed.

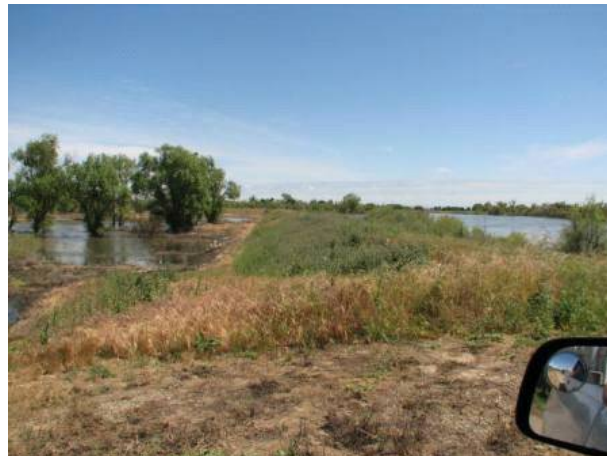
jeto_f_20110923_223.jpg

Levee Mile Report Line	2
Start Levee Mile	0.02
End Levee Mile	0.29
Location	Water Side
Category	Earthen Levee
Item	Vegetation

04/28/2011 Weeds taller than 12" are on both waterside slopes for the full length of the unit. Weeds prevent visibility of the slope and crown.

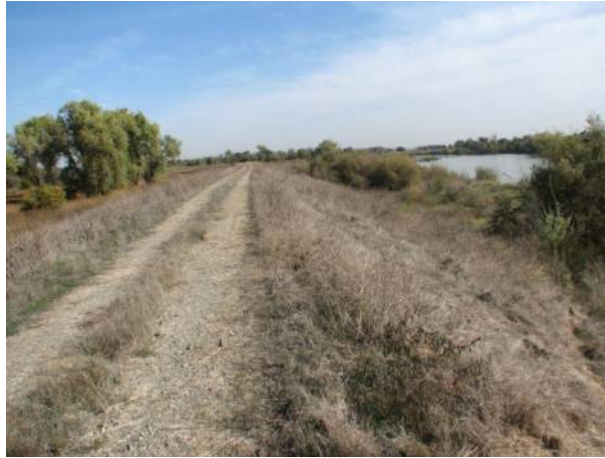
Levee Mile Report Line	2
Start Levee Mile	0.02
End Levee Mile	0.29
Location	Water Side
Category	Earthen Levee
Item	Vegetation
11/03/2011 Vegetation has been sprayed, but needs to be removed.	
jeto_f_20111114_571.jpg
